WETLAND RESTORATION MONITORING REPORT YEAR ONE (2014)

U.S. Environmental Protection Agency Project
#CWA-08-2013-0032
Williston Village Mobile Home Park Wetland Restoration
Williston, North Dakota
Project #4789

October 1, 2014

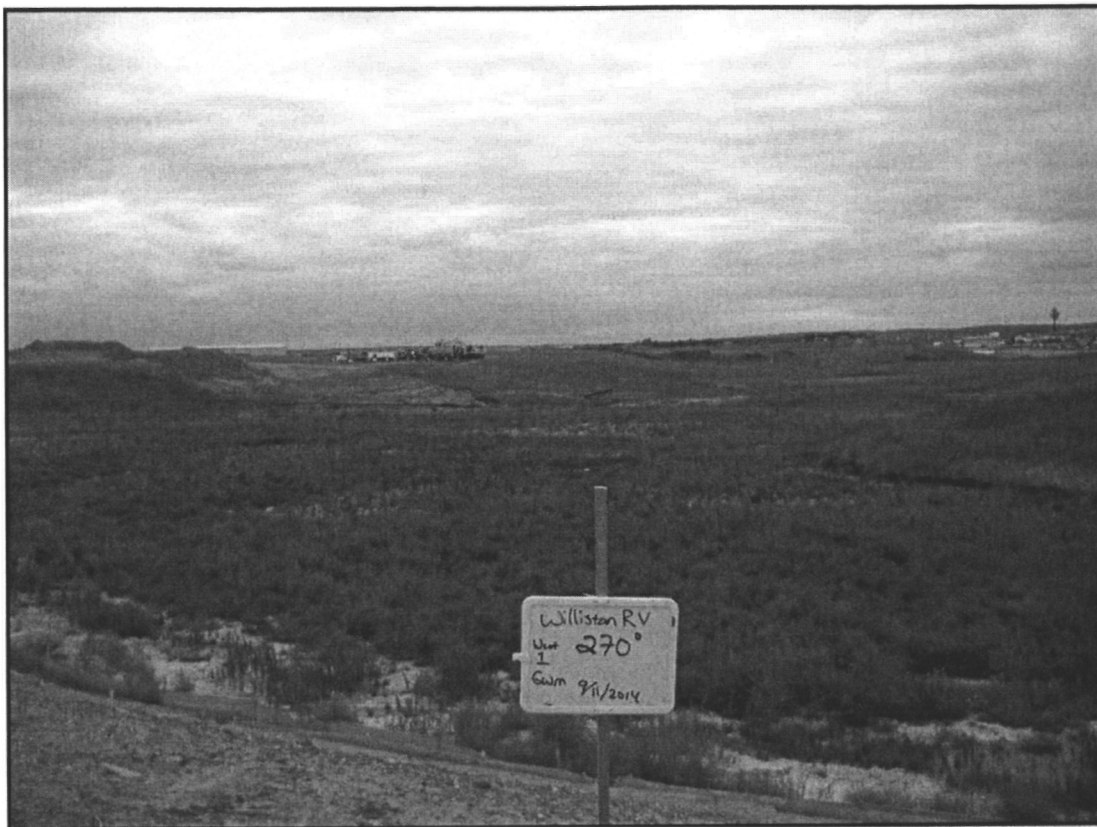
Photograph 1. September 2014 view of restored wetland area. Photograph taken facing west. Natural re-vegetation has taken place within the restored wetland area. Hydrophytic vegetation species comprise approximately 39 percent areal canopy cover while upland species comprise approximately 33 percent areal canopy cover, and bare soil comprises the rest. Patches of cattails along of inundation and saturated soils are present along the base of the southern side-slope near the orange silt fence (foreground). Russian thistle comprises the dark green vegetation in the center of the wetland area. The red vegetation along the western edge of the restored wetland area is comprised primarily of red saltwort.

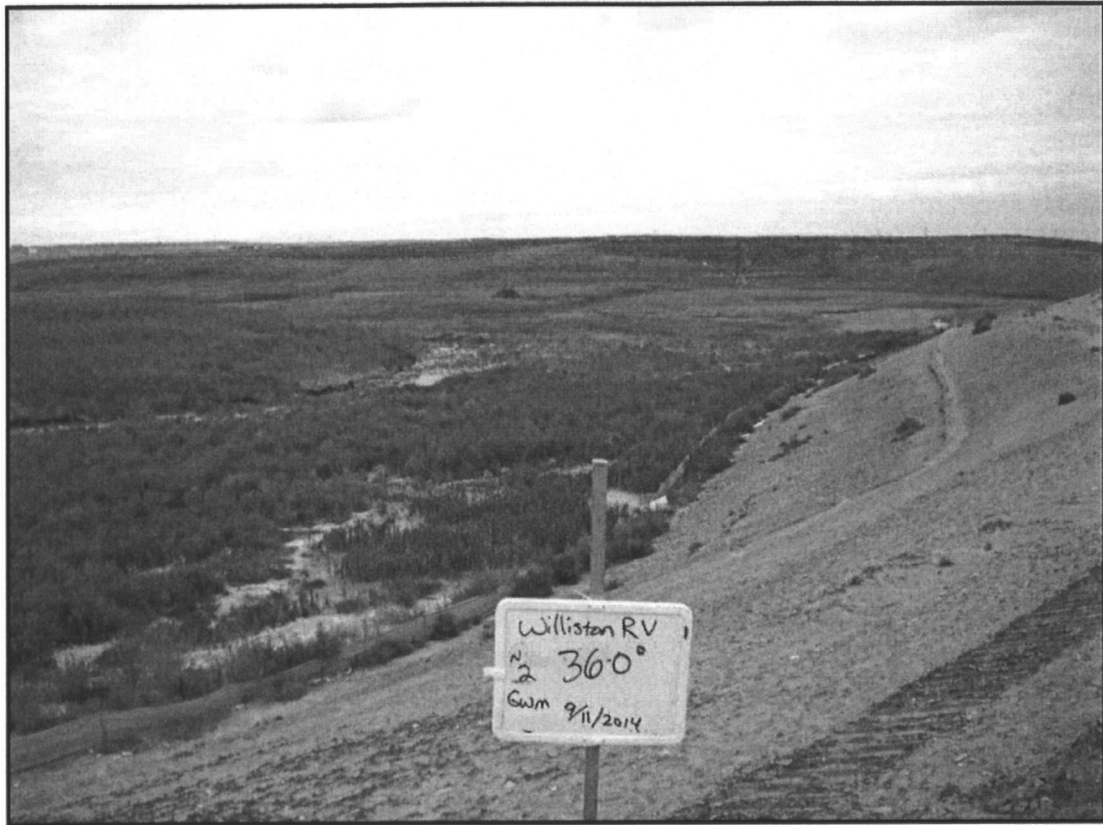
Photograph 2. September 2014 view of restored wetland area. Photograph taken facing north. A large patch of cattails is located at the base of the side-slope along the orange silt fence. Russian thistle is prevalent across the majority of the restored wetland. The area contains high salinity and areas of high salt concentrations were observed (white patches)

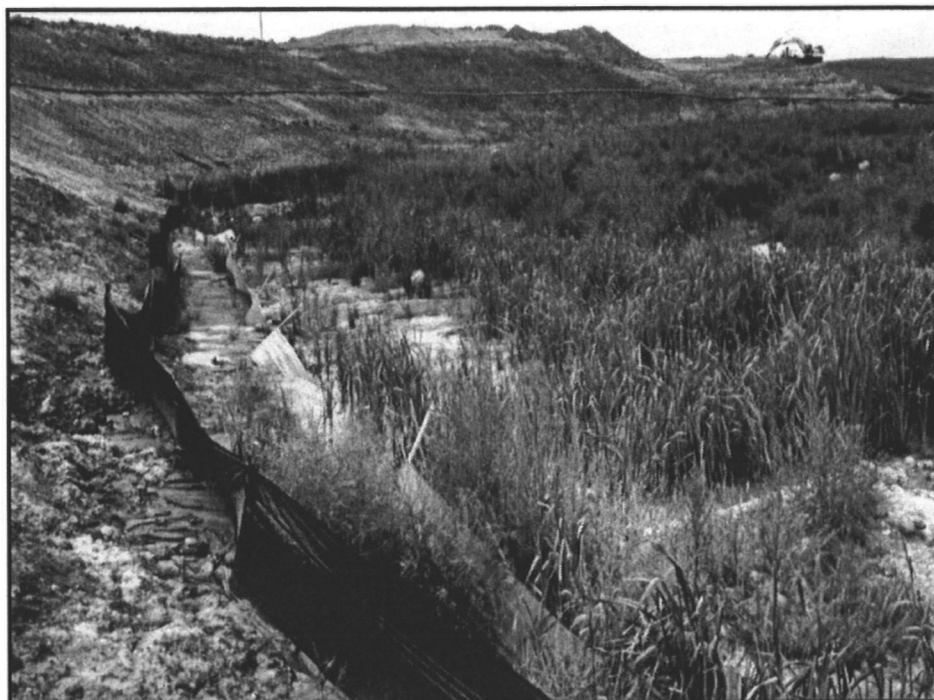
Only one small area of erosion was noted within and around the restored wetland area. A small amount of sediment had knocked down the silt fence. An additional area of silt fence had been erected at this spot to minimize any other erosion prior to the monitoring visit. The straw wattles placed along the side-slopes have significantly reduced erosion along the slopes even though they haven't been planted. The side-slopes are anticipated to be planted next spring during the specified planting dates (May 1-June 15).

Photograph 3. View of eroded area and additional silt fence.

- Maintain the silt fence along the base of the southern side-slope.
- Plant side-slopes with specified seed mixture in the spring of 2015 (Carlson McCain, 2013).

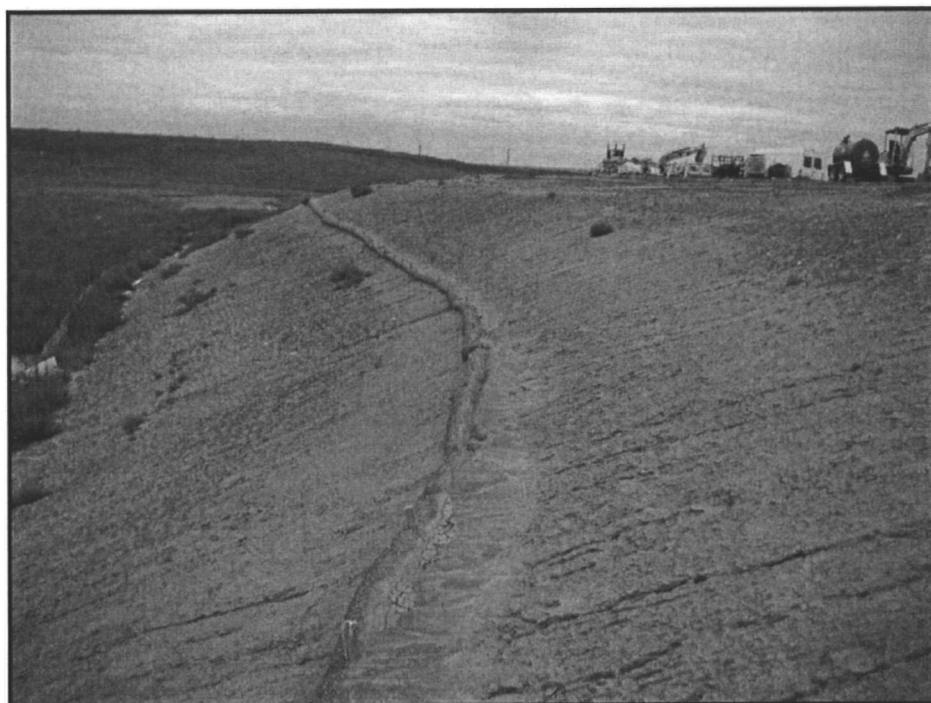
Photograph 4. Straw wattles along the side-slopes. Russian thistle covered the side-slopes throughout the summer but was sprayed with herbicide to control them and prepare the area for seeding. These slopes will be seeded next spring during the specified planting dates (May 1-June 15).

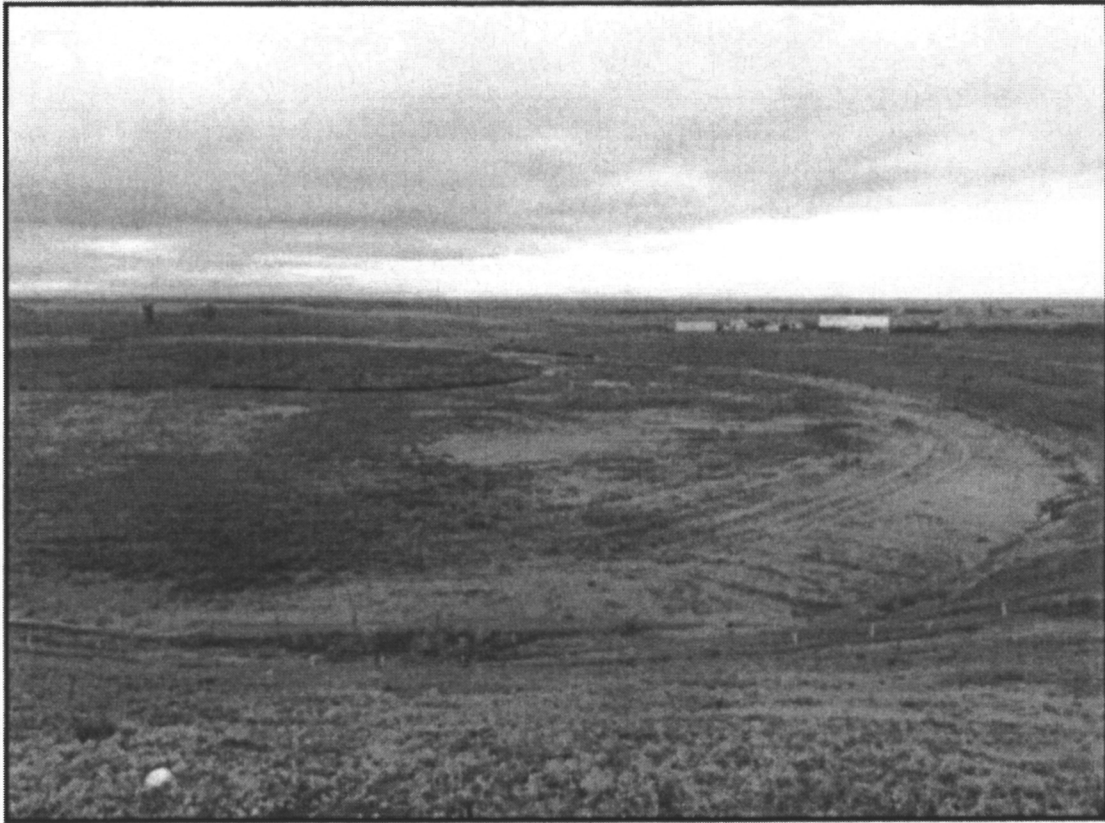
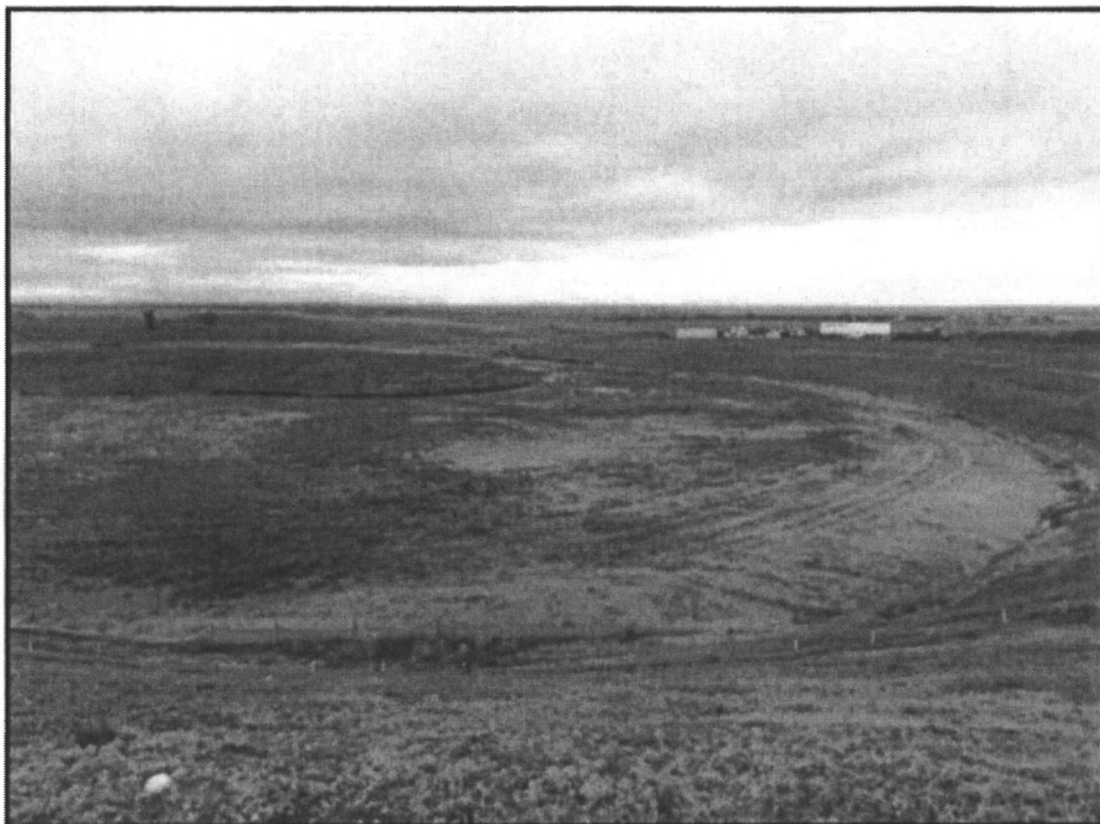
Photograph 1 View of restored wetland area facing north from the adjacent side-slope. The wetland area is being naturally re-vegetated by seeds from the adjacent wetland areas. The erosion control structures are evident in the photograph and these include the orange sediment fence and straw wattles along the side-slopes. These were installed during the fall of 2013. Russian thistle and other weed species have become established on the side-slopes of the restored wetlands. The weedy vegetation is being managed (mowed) and will help with erosion control until the sides-slopes are seeded with the native species seed mixture next spring (2015).

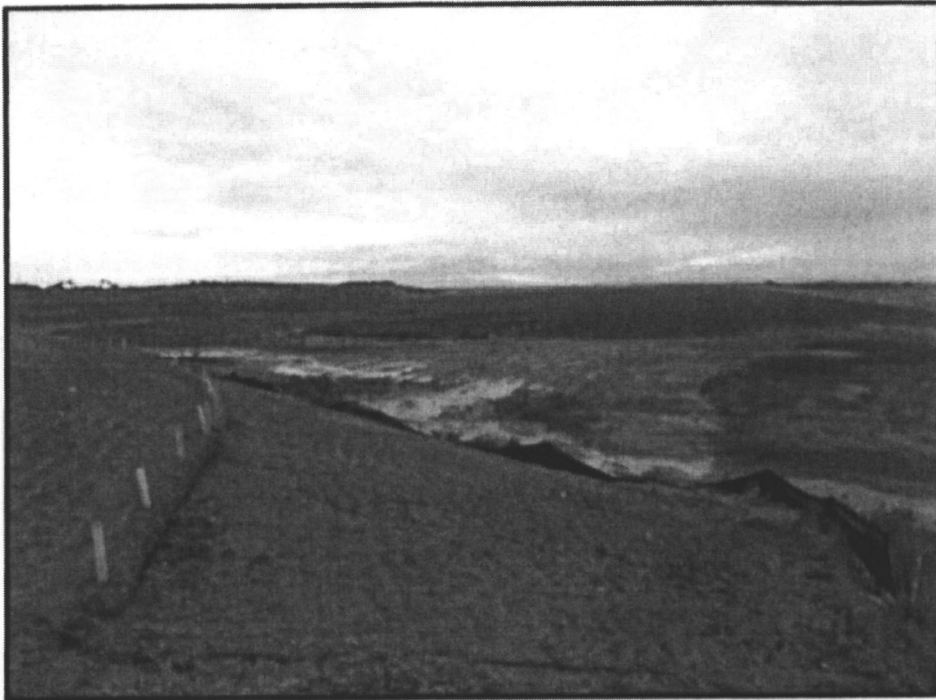
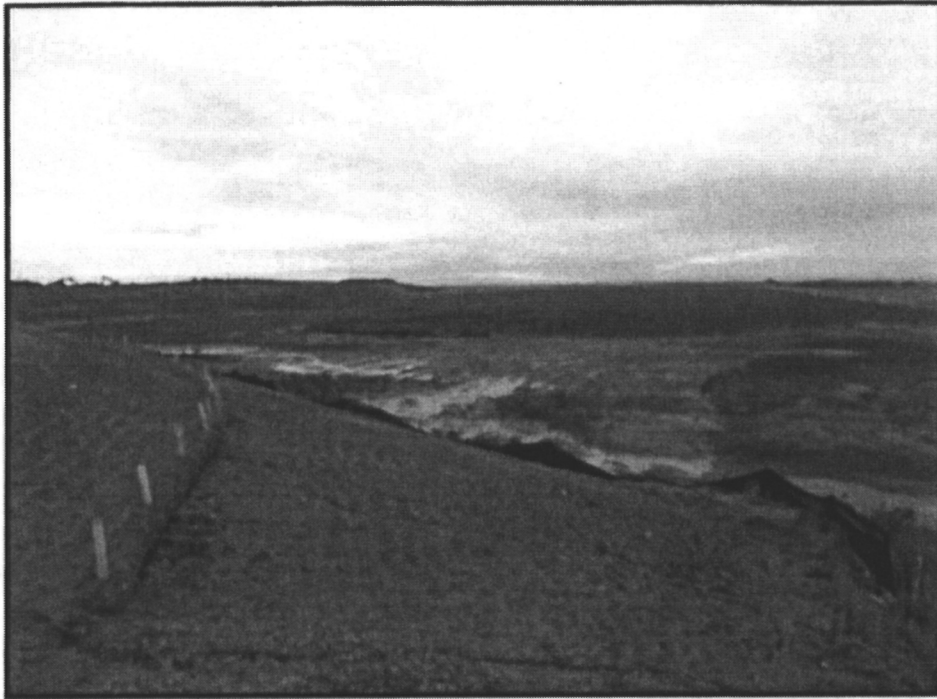
Photograph 2. View of western end of restored wetland area. A distinct line of vegetation indicates the impacted area.

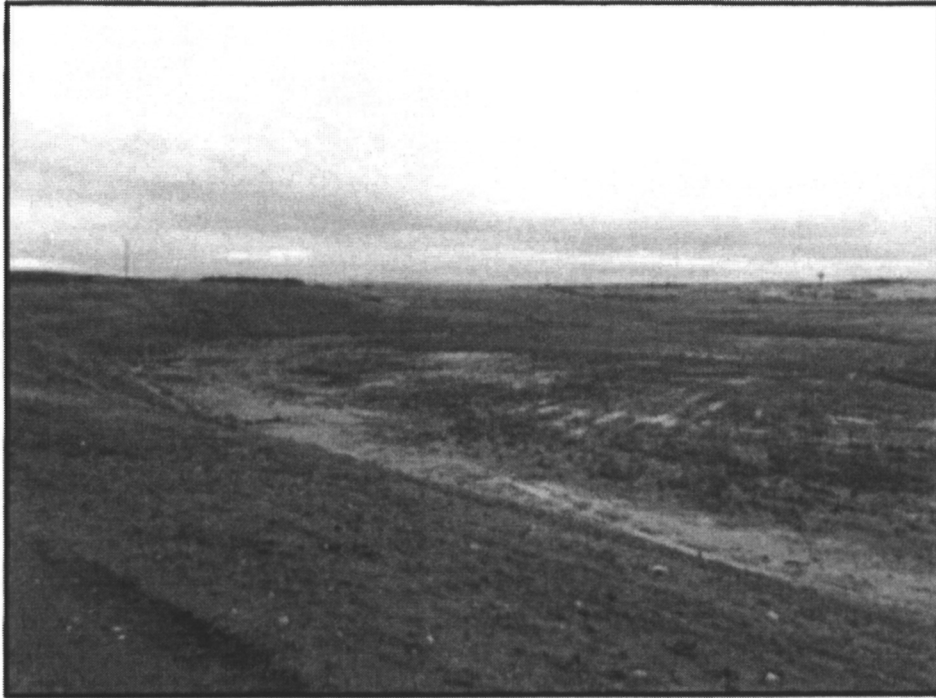
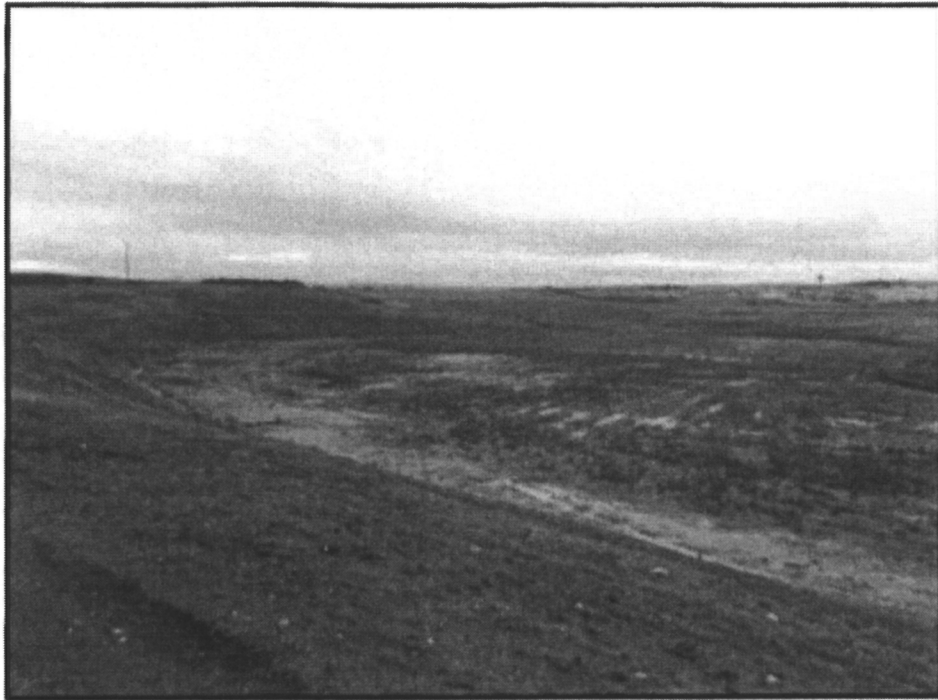
Photograph 4. View of restored wetland area and side-slopes facing west. Small areas of inundation were present in the wetland at the time the photograph was taken.
